EXCELSIOR

New Information On an Enigmatic Steam Locomotive

W G BAGNALL
Works No.970 of 1888

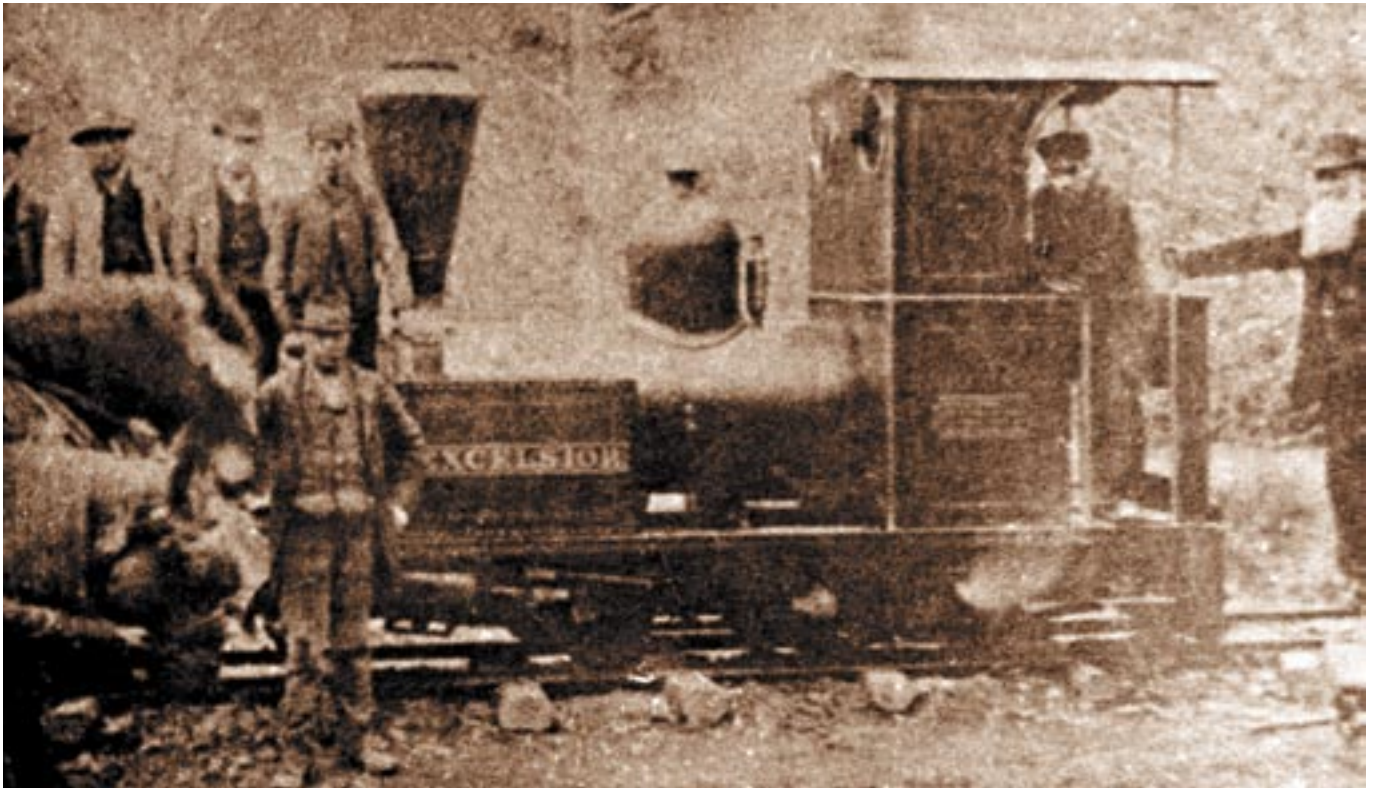
stared and stared! THIS view showed Excelsior as an 0–4–0 on very light track and the dress of the workers suggested a Victorian date, perhaps in the 1880s? This photo clearly predated all other known views of Excelsior – a truly revelatory find!

The photo is on bromide paper, slightly browning with a reddish blemish in one corner – clearly not a contemporary print, but probably a fairly recent copy of a copy, maybe dating from the 1950s or 60s. Unless this is a clever hoax, the photo clearly shows Excelsior complete with name plates and the distinctive Bagnall works plate. Close, very detailed physical examination of the print, and a careful inspection of a huge blow up of the scanned image for any internal discrepancies suggests that this photo is indeed genuine, albeit a copy.

This new photo shows she carried a very fetching spark arrester in her early years (the same one as in the later L&B Collard Bridge view, page opposite), a whistle projecting through the cab roof, and a cab rear lower sheet curved to meet the rear roof pillars. You can also just make out a rectangular access hole in this rear sheet to give access to cleaning the fire or give a bit more space to swing the fireman's shovel. The light and shadows under the cab give no indication of a trailing truck. Unfortunately, the details of the very front of the loco are obscured by the men standing around her. On the original, you can also make out lining on the cab and tank sides.

It is reasonable to conclude that this early view shows her on the Kerry Tramway itself. If this is true, then this is the ONLY known view. From this we can see that the tramway (or at least this portion of it) is laid with very light rails and rough sleepers hewn from logs (what the Americans call appropriately 'pole ties'). What you might expect from such a line of the period. But – was the track the reason why Excelsior was ordered as such a small machine, or the other way round?

Surrounding Excelsior you can make out eight individuals: on the right there is one man in the cab wearing a cap (presumably the fireman/driver), an old white bearded gaffer with his hand on the cab pillar (seems to be standing on a pile of logs or something just out of shot); on the left, four men are standing on the front of the loco or at the same height as the footplate (are they on a flat

wagon?); whilst on the ground in front is another man obscuring the detail of Excelsior's front end. In the right-hand foreground are two draught horses; you can just make out another person's outstretched arm holding the traces of the front horse. With the exception of the presumed driver, are these estate or forestry workers? They certainly look dressed for manual work, and in the style of dress appropriate for the 1880s (and certainly no later than the 1890s).

Obviously, this photo shows that much of the earlier assumed history of Excelsior is wrong and that she had not in fact been built as an 0–4–2 tank. Clearly, she started out as a shorter 0–4–0, but when was she rebuilt? Obviously, this must have happened sometime between the date of this photo and the next known view of her on Collard Bridge or Rolle Quay, Barnstaple as an 0–4–2 during the

construction of the L&B in 1896-97. Frankly, we don't know for sure but presumably she had proved to have too small a water capacity and was fitted with a 'back-tank' over a rear extension. This would have extended her range and altered her balance, possibly for the better. But was this alteration carried out whilst still working the Kerry Tramway or had she been rebuilt and improve her saleability to an industrial buyer or contractor prior to eventual sale to Edmund Nuttalls, contractor to the L&B? I wonder who carried out this work; it looks a very neat job – Bagnalls perhaps? Excelsior originally built as an 0–4–0 makes much more sense of the apparent light weight of just 3tons 15cwt in working order, as stated by Cozens.

Both Roy and I have made digital copies of this image, and we have both had a go at removing the specks, blemishes and scratches. Once these visual distractions have been taken away, we both found that what faintly emerges (and hopefully you can see in the published version here), is a background of trees, specifically fir or spruce trees – just the plantation species you would expect as a backdrop for a forestry estate railway! The horses are probably hitched to a cart or trolley for hauling logs from the cutting area to a convenient point on the tramway, as they are positioned and harnessed for two-aside haulage. To my mind this is further confirming evidence that we are looking at some location on the Kerry Tramway, possibly a loading area near the switchbacks in LLwyn-y-Rhwd Dingle. The light and slope of the ground in relation to the direction of the loco would seem to preclude this being in the Rhos Dingle. Other Kerry experts please comment via the Editor!

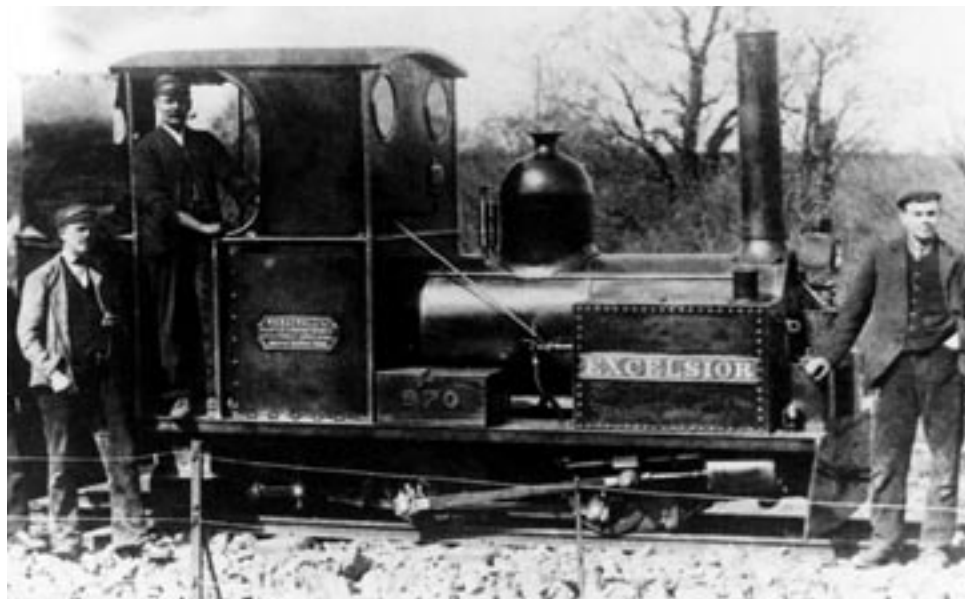
EXCELSIOR as she is most often remembered, with a stovepipe chimney and crude cab back sheeting. This photo, taken while the loco was working on the L&B contract, is the only one known that shows the right hand side of the loco in any detail. All other close ups favour the left elevation.

Points of interest are: the bent front buffer beam, injector piping and sloping control rod, tool box (bearing the works number) and the lack of obvious cylinder drain cocks on this side. A bucket is wedged between the sandboxes at the front and the tip of a re-railing bar protrudes from the top of the LH tank. The chimney appears to utilise the cast base of the original spark arresting stack.

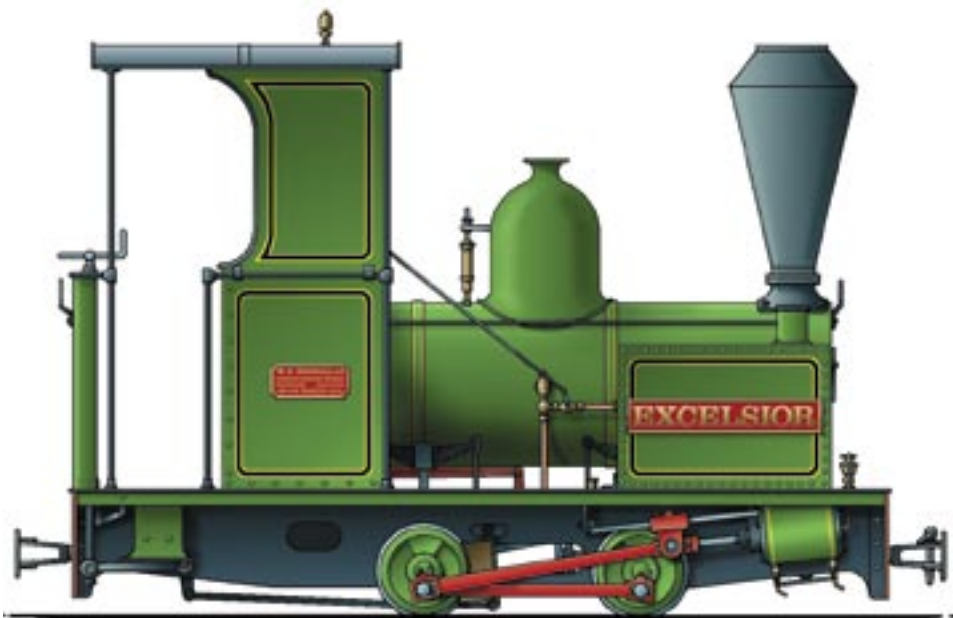
EXCELSIOR

See text for known
dimensions - all others conjectural.

©Roy C Link 2002 Scale — 1:32

CONDITION AS BUILT — 1888
